Appendix B
Communities

Purpose

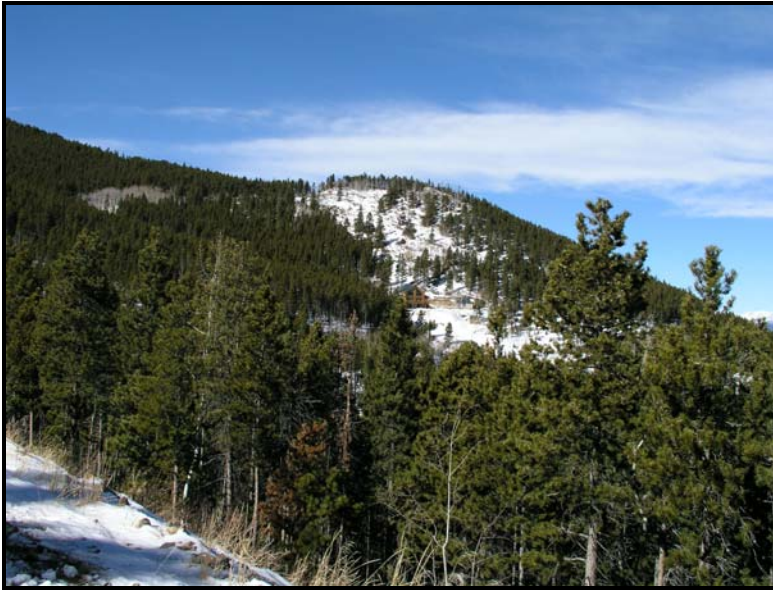
Figure 4

Hazard Rating:	Extreme
Does the neighborhood have dual access roads?	No
Are there road grades $\geq 10\%$?	Yes
Are all access roads of adequate width?	No
Average lot size:	>5 Acres
Fuel models found in the neighborhood:	8, 10
Water supply:	None
Hazards:	Steep slopes, inadequate access roads, natural chimneys, ravines, no water supply, and homes in saddles.

Although the two main roads in this community are generally of adequate width, they are dead ends with few turnarounds. Some driveways are quite long and are steep, narrow and rocky. Access and egress would be difficult in fire conditions. Homes are built mid-slope, some in saddles and above ravines, on slopes of up to 60%. The area has heavy loads of FM 8. There are many dense stands of decadent lodgepole pine. The dominant construction type is mostly newer homes on large lots, but most are poorly mitigated. Most homes have no or inadequate addressing. Some yards are in need of clean up. Low structure density is the only bright spot in this community and that is likely to change.

Reduce ladder fuels and thin the slopes below homes. Improve roads, address signage, and turnarounds. Improvement in the water supply is critical (see Water Supply FMZ). Most homes need defensible space. Extended defensible spaces and adequate shelter-in-place areas or safety zones are highly recommended. A parcel level analysis of this neighborhood is recommended.

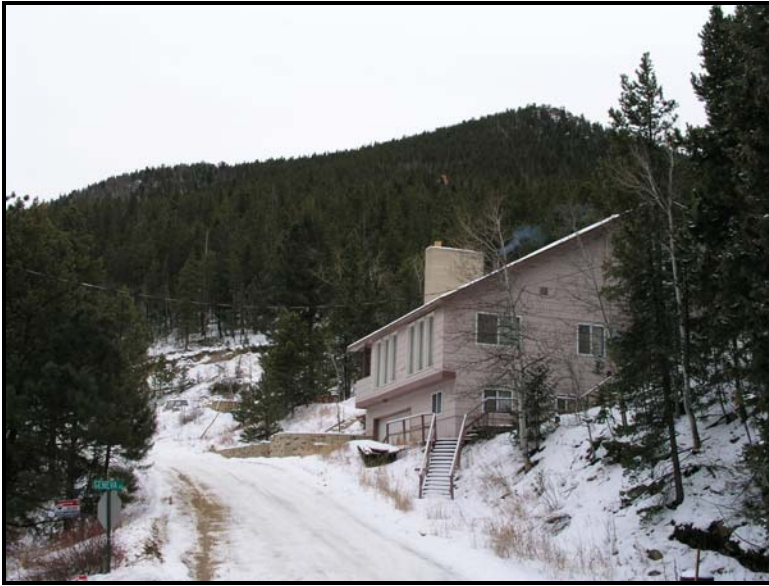
Figure 5

Hazard Rating:	Extreme
Does the neighborhood have dual access roads?	Yes
Are there road grades $\geq 10\%$?	Yes
Are all access roads of adequate width?	No
Average lot size:	<1 Acre
Fuel models found in the neighborhood:	8, 10
Water supply:	None
Hazards:	Ravines, inadequate access roads, no water supply.

Although the access along Drew Hill and Ralston Creek Road is good, there are many homes built up steep side roads and driveways. Even along Ralston Creek Road, some homes would be difficult to access because of heavy vegetation growing right up to the structures, cluttered yards, narrow driveways and difficult or absent turnarounds. There are missing or inadequate street signs and addressing throughout the area. Many homes are built mid-slope or at the top of steep slopes. North facing slopes average 25% and south aspects reach 40%. There is a heavy fuel load and a continuous canopy with plentiful ladder fuels. Most of the construction in the area consists of older wooden homes. Firewood stacks and other manmade fuel jackpots are common near structures. There are many parcels with tree limbs touching the structures. The nearest water supply is draft water from ranch ponds in Golden Gate State Park, about 1.5 miles away.

Thin conifers and reduce ladder fuels on slopes below homes. Clean up dead and down material. Add reflective street and address signage. Thin trees along roadways. Improve driveways and turnarounds. If it is not possible to create additional escape routes, consider developing shelter-in-place areas or safety zones. Extended defensible space should be considered for homes located mid-slope. Clean up flammable yard clutter. Cisterns should be added especially for homes that are not close to Crawford Gulch Road. Most homes in this area need defensible space. A parcel level analysis of this neighborhood is recommended.

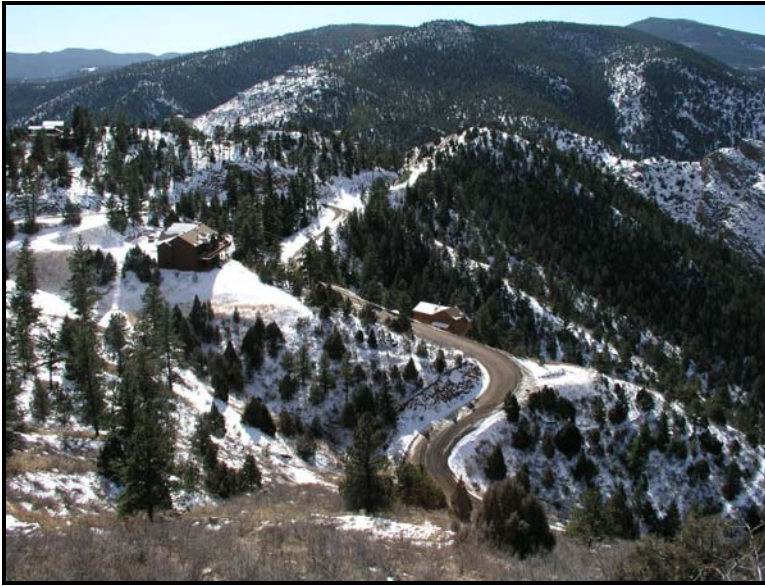
Figure 6

Hazard Rating:	Extreme
Does the neighborhood have dual access roads?	Yes
Are there road grades $\geq 10\%$?	Yes
Are all access roads of adequate width?	No
Average lot size:	1-5 Acres
Fuel models found in the neighborhood:	2, 6, 9, 10
Water supply:	None
Hazards:	Ravines, natural chimneys, homes in saddles, steep roads and no water supply.

This community is built along both sides of a predominately north/south side canyon that connects Robinson Hill with Clear Creek Canyon. The north and west facing slopes of this steep canyon have high fuel loads of mixed conifers. Most homes do not have addressing that is visible from the road. The most common construction type is wood siding with asphalt roofs. Although fuel loads are moderate at the top of the canyon (FM2) there are heavy fuel loads of mostly FM 9 and 10 around and below homes. Most homes are built at the top and middle of steep slopes, many at the top of natural chimneys and other hazardous terrain features. Secondary roads and driveways are steep and many homes have inadequate turnarounds. All of the roads except Douglas Mountain Road appear to be dead ends.

This area desperately needs cisterns. Tender relays from the nearest water supply would be slow and easily cut-off. Landscape scale fuel breaks would be hard to construct here due to the steepness of the terrain. Extended d-spaces and thinning below homes is highly recommended. Thinning in the gullies below Douglas Mountain road is needed to protect the access. Most homes need defensible space. Shelter-in-place tactics should be considered in this area due to easily threatened access. Improved turnarounds should be considered at residences and on secondary roads. Most homes need reflective addressing that is visible from the road. A parcel level assessment is recommended for this community

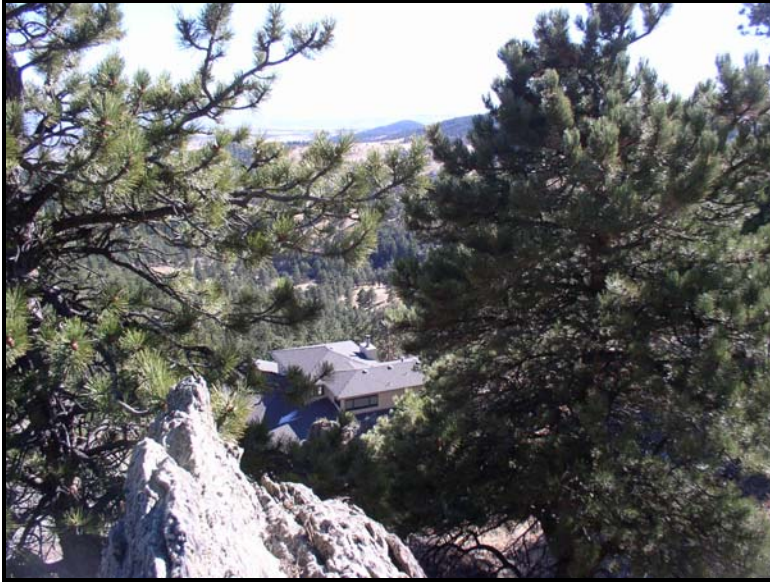
Figure 7

Hazard Rating:	Very High
Does the neighborhood have dual access roads?	No
Are there road grades \geq 10%?	Yes
Are all access roads of adequate width?	Yes
Average lot size:	>5 Acres
Fuel models found in the neighborhood:	1, 2, 9, 10
Water supply:	10,000 gal. cistern on Misty Road
Hazards:	Steep slopes, natural chimneys, ravines, steep narrow driveways, inadequate water supply.

This exclusive neighborhood consists of large recently constructed homes on large lots. Most homes have ignition resistant roofs and some have ignition resistant external walls. There are many homes built at the top of steep ravines, some over 40% slope, with heavy loads of dog-hair lodgepole pine and Douglas-fir (FM 9 & 10) especially on the north end of Homestead Road. Misty and Homestead Roads, which are the primary access, are steep but of adequate width. Turnarounds are few and many driveways have tight switchbacks, are steep, narrow and overgrown with fuels. Easily cut off single access, heavy fuels, inadequate water supply and high values-at-risk combine to make this a very hazardous area.

There is one 10,000 gallon cistern for this entire area and it does not appear on the GGFDF list of water sources. This cistern needs to be marked, mapped and access to it improved. This rapidly growing area needs more cisterns, as ponds do not seem to be reliable or easily accessed. Misty and Homestead Roads need thinning to at least a 300' width to protect access and egress. Many homes need defensible spaces, and extended defensible spaces should be considered for homes located above ravines with hazardous fuel loads. The maintenance of a safety zone meadow by irrigation or mowing should be considered. A parcel level analysis of this neighborhood was conducted in 2002. An extensive shaded fuel break is being implemented in the fall of 2004 as a result of the findings of the 2002 study.

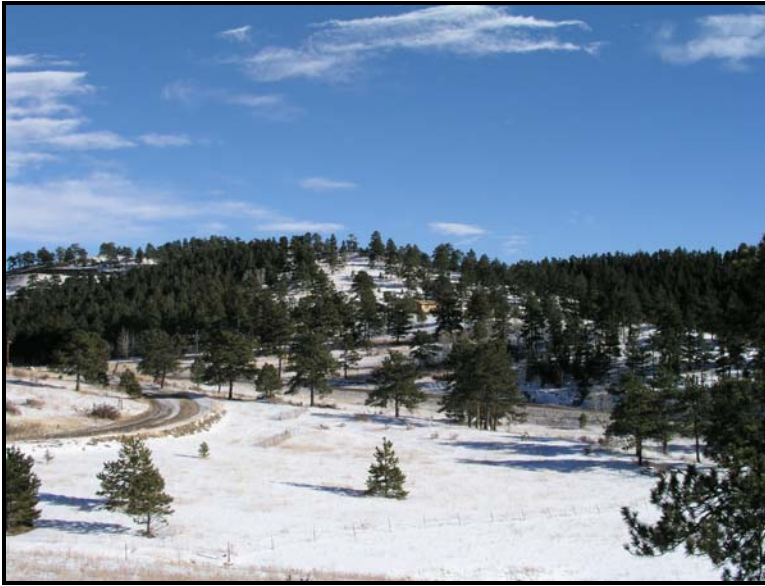
Figure 8

Hazard Rating:	High
Does the neighborhood have dual access roads?	No
Are there road grades $\geq 10\%$?	Yes
Are all access roads of adequate width?	No
Average lot size:	1-5 Acres
Fuel models found in the neighborhood:	1, 2, 9, 10
Water supply:	Cisterns on both sides of Douglas Mountain Road.
Hazards:	Steep draws, ravines.

Homes in this area are built on both sides of the wide canyon bottom that runs southwest from the intersection of Robinson Hill Road and Douglas Mountain Road and up steep side roads mainly on the northwest side of Douglas Mountain Road. Slopes below homes are generally not as steep as in Douglas Mountain-South, averaging 15-25%. The majority of the east side of Douglas Mountain Road consists of ranches located in fuel models 1 and 2. Development throughout this community consists of widely scattered clusters of homes varying from older ranch homes to recent construction with ignition resistant roofs. Most homes have wood siding, and in the area west of Douglas Mountain Road the majority are located above heavy loads of fuel models 9 and 10. Addressing is better in this area than most of the district, but many homes need defensible spaces.

Fuels reduction and slash removal should be done downhill of homes and along access road, especially in the northwest portion of this community. Most homes need defensible space and some need yard cleanup. Since there is a single access to the homes in the western area, the development of shelter-in-place areas and/or safety zones is strongly recommended. Although Douglas Mountain Road has adequate fuels clearance, fuels reduction is a critical need on side roads and driveways. A parcel level analysis is recommended.

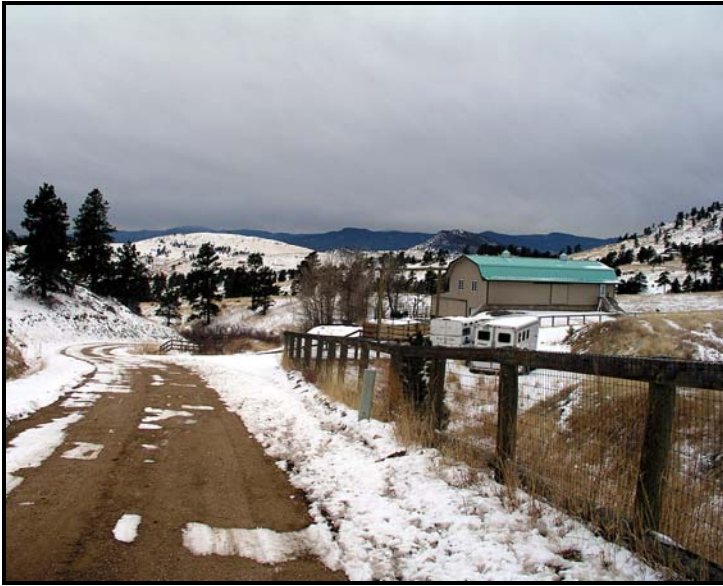
Figure 9

Hazard Rating:	High
Does the neighborhood have dual access roads?	No
Are there road grades $\geq 10\%$?	Yes
Are all access roads of adequate width?	Yes
Average lot size:	>5 Acres
Fuel models found in the neighborhood:	2
Water supply:	Draft water from stock ponds (not reliable)
Hazards:	Ravines, inadequate roads and no water supply

Fuels are mostly moderate loadings of FM1 and FM2. Although most roads are of adequate width, some driveways and private roads are very steep and narrow. Residences are mostly ranch houses, many older, on large, widely spaced lots. Some homes have combustible materials near structures and propane tanks. On Mica Mountain Road a noticeable quantity of ponderosa pine has been cut and the slash left or piled at the side of the road. Many homes need defensible space and yard cleanup.

Eliminate standing dead, and remove red needle slash from old cuttings. Clear grasses and combustible materials away from structures and propane tanks. A reliable water supply is critical for this area. At least two large (10,000 gallon or larger) community cisterns are recommended. Reflective address signage is needed for most homes and driveways. Yard clean up for most homes is recommended. A parcel level analysis is recommended.

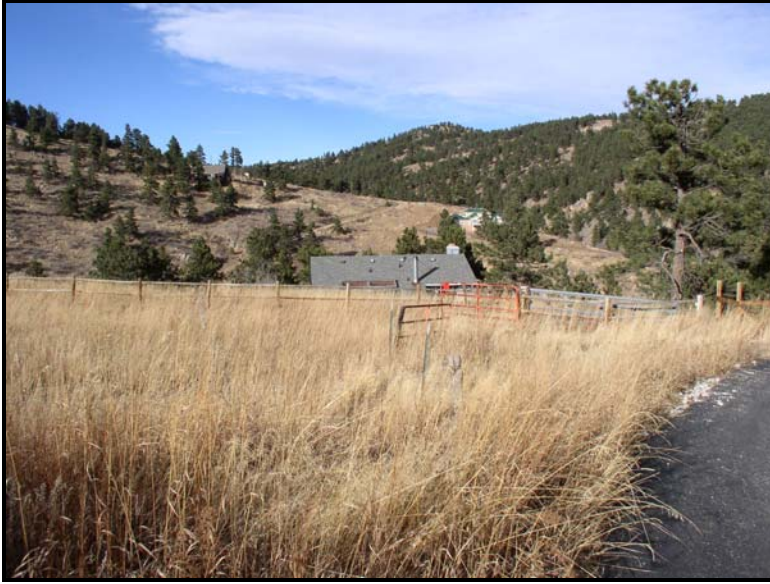
Figure 10

High

Ravines, inadequate roads

Most homes in this community are built on ridge tops or on the upper 1/3 of the slopes above both sides of the canyon bottom. Although FM 1 and 2 dominate, in some areas the fuel bed depth of grasses is almost enough to qualify as FM 3. Addressing is very confusing with random numbers appearing at a major fork in the road. There are at least two different numbering schemes present and many properties have no address signage. Some homes are located up steep driveways and private roads, many with locked gates. There are some low power lines in this area that may prevent the use of larger apparatus. In the western part of the community homes become more spread out along very long driveways with few turnouts. This area can be escaped to the west by using private ranch roads.

Addressing needs to be straightened out. Confusing signs should be replaced with reflective markers showing clear directions. More cisterns are needed especially in the western area. Stock ponds should be investigated for landowner cooperation and possible dry hydrant installations. Homes need defensible space and mowing. Extended defensible spaces, especially for homes on the north side of the canyon, are recommended. A parcel level analysis is recommended.

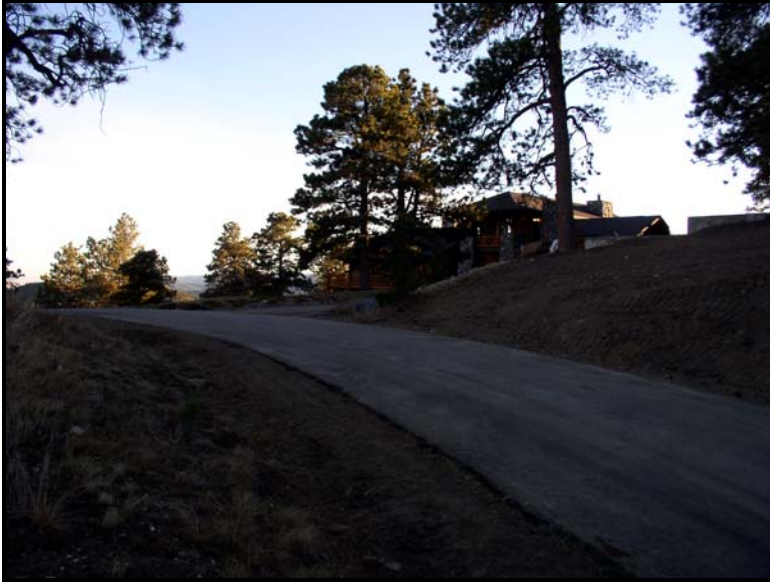
Figure 11

Hazard Rating:	High
Does the neighborhood have dual access roads?	No
Are there road grades $\geq 10\%$?	No
Are all access roads of adequate width?	Yes
Average lot size:	1-5 Acres
Fuel models found in the neighborhood:	2
Water supply:	Cisterns (7,000 to 30,000 gallons)
Hazards:	Houses on ridge tops, steep slopes, ravines

This area has had some mitigation. Limbing and thinning near homes is apparent, however this small community of luxury homes is located at the top of a ridge. Fuels in the community are mostly FM2, but the slopes below some homes have heavy FM 9 especially in ravines. There is no reflective address signage in this community. There is only one way in and out of this gated community. Access roads are paved and of adequate width, but turnarounds that are adequate for fire apparatus are scarce. There is a 30,000 gallon cistern at the entrance to this community that does not have a fire department connection and is therefore useless for fire suppression.

Even though there is a 7,000 gallon and an 8,000 gallon cistern across Belcher Hill Road from this area, the 30,000 gallon cistern should be considered the primary water supply for this community and must be fitted with a proper FDC. Fuels should be thinned on slopes below homes. Extended defensible spaces should be considered for homes directly above hazardous slopes. All homes need reflective addressing. A parcel level analysis is recommended.

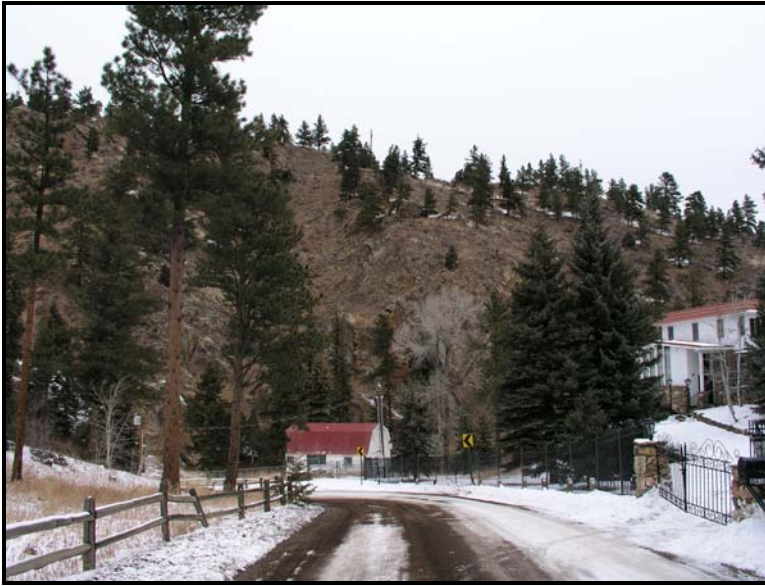
Figure 12

Hazard Rating:	High
Does the neighborhood have dual access roads?	Yes
Are there road grades $\geq 10\%$?	Yes
Are all access roads of adequate width?	No
Average lot size:	>5 Acres
Fuel models found in the neighborhood:	2, 9, 10
Water supply:	Possible draft water from stock ponds (all are hard to get to).
Hazards:	Ravines, inadequate access roads and no water supply

This area is characterized by scattered homes on large lots. Many are located away from Drew Hill Road, the primary access, on long narrow driveways with no or poor turnarounds. The topography in this area is quite steep and there is an appreciable quantity of dog-hair stands of lodgepole pine and mixed conifer (FM 9). Some homes in this area are located at the top of steep slopes of FM 9 and 10. The 477 acre Spirit Mountain Ranch at the south end of this area could become a major development.

Most homes need extended defensible space because of heavy fuels. As with all structures located in the canyon bottoms ignition resistant roofs are highly recommended to prevent ignitions from ember cast and rolling materials. Address signage needs improvement. Individual cisterns may be the best choice for water supply needs in this area, although one or two large (10,000 -30,000 gallon) cisterns would be advisable for Spirit Mountain Ranch depending on what the final structure density is. A parcel level analysis is recommended.

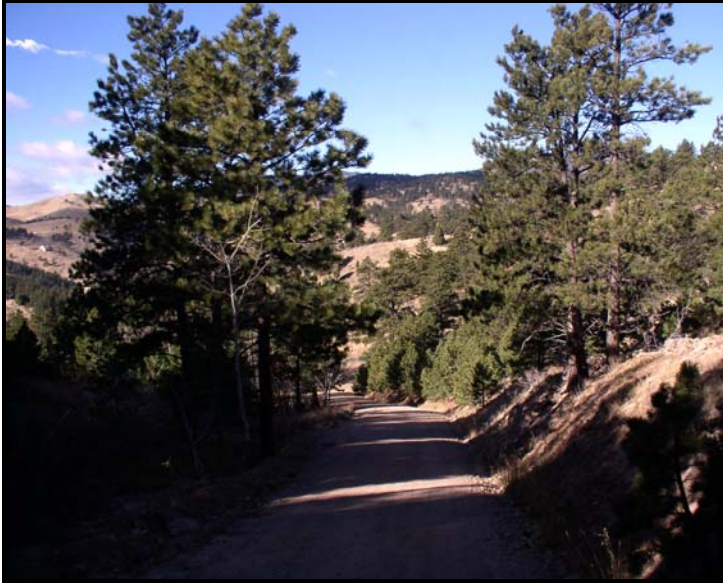
Figure 13

Hazard Rating:	High
Does the neighborhood have dual access roads?	No
Are there road grades $\geq 10\%$?	Yes
Are all access roads of adequate width?	Yes
Average lot size:	>5 Acres
Fuel models found in the neighborhood:	1, 2, 9, 10
Water supply:	None
Hazards:	Steep narrow roads, ravines, no water supply

This neighborhood has steep roads with few turnarounds. There are heavy surface loads of FM 2 (ponderosa pine with grass understory) in this area, with some FM 9 and 10 (mostly fir, aspen and juniper) in north facing drainages. The primary access road has a 15% grade and there are driveways in this area that go up 25% slopes. The primary access is of sufficient width but there are no turnarounds until the road reaches the plateau. Address markers are missing or inadequate for most homes. There is a low power line near the county shops that may prevent the access of larger apparatus. The Grange building may make a good evacuation center. Heavy equipment and fuel are available next door at the county shops.

Access roads need fuel reduction. Homes are spread out enough so that individual cisterns may be the best solution to the water supply problem. Add reflective address signage. Mow grasses away from structures. Develop shelter-in-place areas and/or safety zones. Most homes need defensible spaces. A parcel level analysis is recommended.

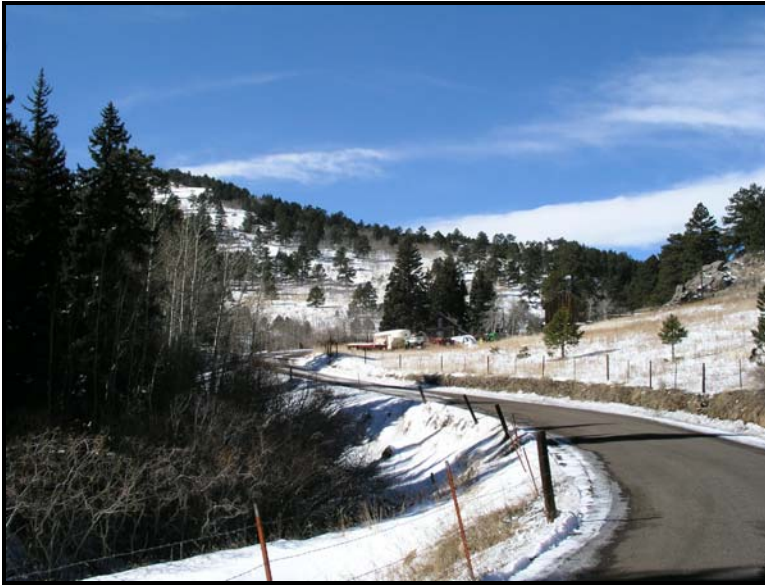
Figure 14

Hazard Rating:	High
Does the neighborhood have dual access roads?	Yes
Are there road grades $\geq 10\%$?	No
Are all access roads of adequate width?	No
Average lot size:	>5 Acre
Fuel models found in the neighborhood:	1, 2, 9, 10
Water supply:	Cisterns of various sizes (at least 3 sites)
Hazards:	Ravines, inadequate access roads, cluttered yards,

The area, which is to the west of Douglas Mountain Road, is quite different than the eastern side of Robinson Hill. Homes here are built along a mainly east/west running canyon bottom with slopes of 20% to 40% above homes. Most homes are located mid-slope. Many have long, narrow, steep driveways with tight switchbacks. Many of the buildings in this area are older wood siding construction, some with wooden roofs. There are historic ranch buildings in this community. Primary fuels in this area are moderate loads of FM 2 broken by grassy meadows (FM 1) with some patches of FM 9, mostly in north facing drainages. There is more insect mortality in this area than in other GGFPD communities. Combustible yard clutter also makes the fuel loading more hazardous in this area. At Raptor Point, Robinson Hill Road becomes Road 8, which provides an escape route into Gilpin County. This road is narrow and winding with very few turnarounds.

Most homes in this area have reflective addressing and street signage is good. Many driveways and private roads need fuels reduction. Any improvements in road widths and turnarounds that are possible should be considered. Standing dead trees should be thinned and dead and down materials cleaned up. Many yards need clean up and most homes need defensible space. A parcel level analysis is recommended.

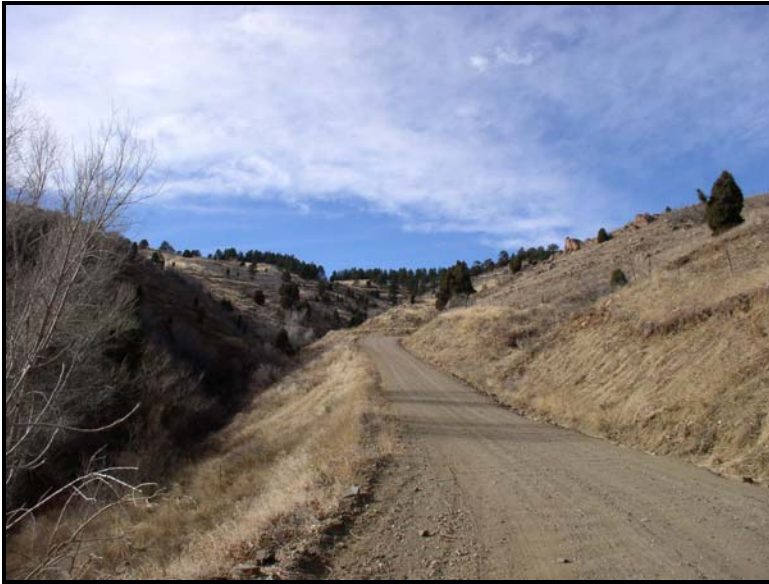
Figure 15

Hazard Rating:	High
Does the neighborhood have dual access roads?	No
Are there road grades \geq 10%?	Yes
Are all access roads of adequate width?	No
Average lot size:	>5 Acre
Fuel models found in the neighborhood:	1, 2
Water supply:	2,000 gal. cistern at 22441 Golden Gate Canyon Road
Hazards:	Inadequate water supply, low power line

This community has moderate fuel loads of mostly short grasses (FM 1). Homes in this area are primarily newer construction types on large lots. Most are located on the tops of ridges and defensible space could be improved by mowing grasses away from structures. Many homes have steep, narrow driveways with poor turnarounds for trucks. Addressing is poor or missing throughout the area. There is a low power line at 245 Bear Road that may be a problem for larger apparatus.

Mow around structures. Improve address signage. Driveway improvements and turnarounds are recommended. Individual cisterns or two or three large (10,000 to 30,000 gallon) community cisterns are recommended. A parcel level analysis of this neighborhood is recommended.

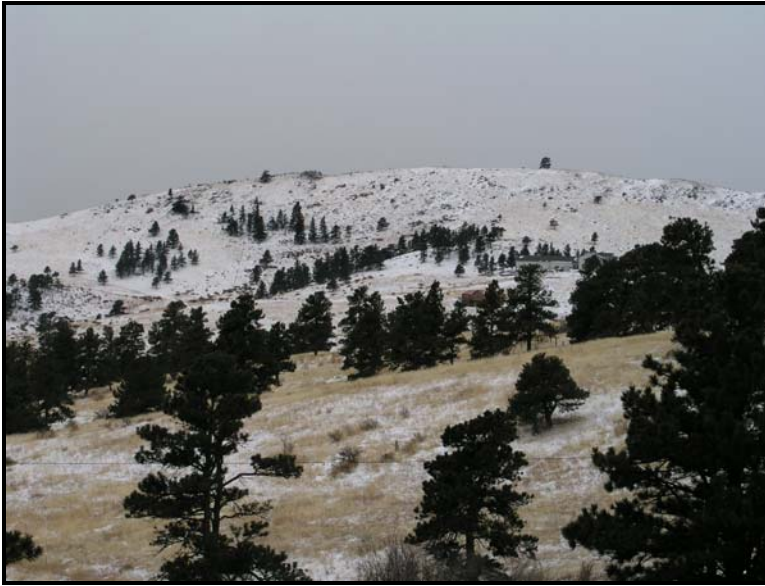
Figure 16

Hazard Rating:	Moderate
Does the neighborhood have dual access roads?	Yes
Are there road grades $\geq 10\%$?	Yes
Are all access roads of adequate width?	Yes
Average lot size:	>5 Acres
Fuel models found in the neighborhood:	1, 2
Water supply:	Cistern on Guy Hill Road and ponds on Golden Gate Road
Hazards:	Ravines, equipment parked in driveways, gasoline tanks

This area is very similar to Horseradish Gulch, but the terrain is not as steep and fuels loads are lighter. The only three homes here are older construction types on large lots. Homes have ignition resistant roofs with wooden exterior walls. Roads and driveways are steep in spots, but most are of adequate width. One residence has equipment partially blocking the driveway and there are gasoline tanks on at least one property. Fuels are predominately FM 1 and some FM 2 in the lower canyon where residences are concentrated. The terrain becomes steeper at the upper end of the canyon and there is a greater density of shrub fuels. There are communication towers, located at 5318 Rye Gulch Road, built on the top of the ridge. A secondary access connects Rye Gulch Road with Guy Hill Road but this is rough and may require 4WD.

Move equipment from driveways and locate gasoline tanks away from structures. Mow grasses away from structures. All homes need reflective addressing. Improve the secondary access to Guy Hill Road.

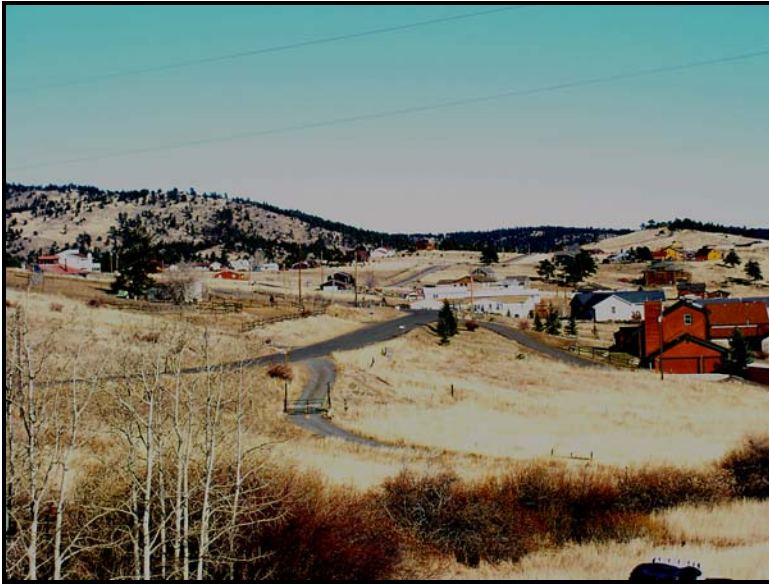
Figure 17

Hazard Rating:	Low
Does the neighborhood have dual access roads?	Yes
Are there road grades $\geq 10\%$?	Yes
Are all access roads of adequate width?	Yes
Average lot size:	>5 Acres
Fuel models found in the neighborhood:	1, 2
Water supply:	Ponds, tanks and cisterns.
Hazards:	Ravines

The only fire station in GGFPD is in this community. Homes are primarily newer construction types. Most have wooden external walls with ignition resistant roofs. The dominant fuel model is short grass (FM 1) with some FM 2 on north and west facing slopes. Most homes have good defensible spaces and visible addressing. Plentiful water, proximity to the fire station, mostly flat terrain and light fuels combine to make this a low hazard community. Problem areas would include the few homes located up steep driveways off the steep portion of Robinson Hill Road and homes along Calle Louisa that are located above steep slopes.

Thin slopes below homes on Calle Louisa and along the steep driveways off the eastern portion of Robinson Hill Road. Extended defensible spaces for homes above steep slopes. Mow grasses away from structures and add address markers for homes that do not have them.

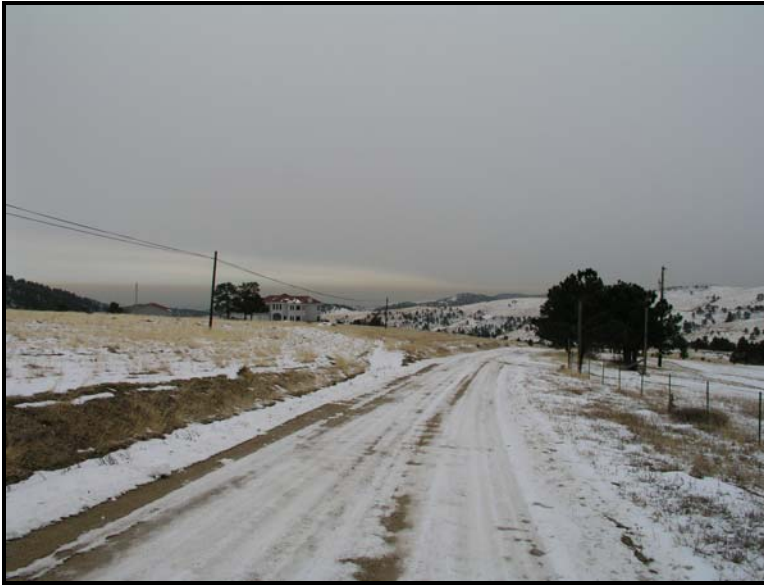
Figure 18

Hazard Rating:	Low
Does the neighborhood have dual access roads?	No
Are there road grades $\geq 10\%$?	No
Are all access roads of adequate width?	Yes
Average lot size:	>5 Acre
Fuel models found in the neighborhood:	1, 2
Water supply:	Dry hydrants
Hazards:	Ravines

This area has moderate to light loads of primarily FM 1. Homes are primarily new construction on large lots. Most structures are built on flat or gently rolling terrain on the tops of broad ridges. Some homes in the Daydream Road area have ravines of up to 22% slope below structures, but fuels are still light to moderate loads of FM 1 and FM 2. North of the residences on the north side of Golden Gate Road, Guy Hill Road becomes narrow and passes through some heavier fuels, but this area appears to be uninhabited.

Some homes need reflective address markers and grasses mowed away from foundations. Fuels should be thinned on both sides of the narrow portion of Guy Hill Road to make it a more viable access/egress route.

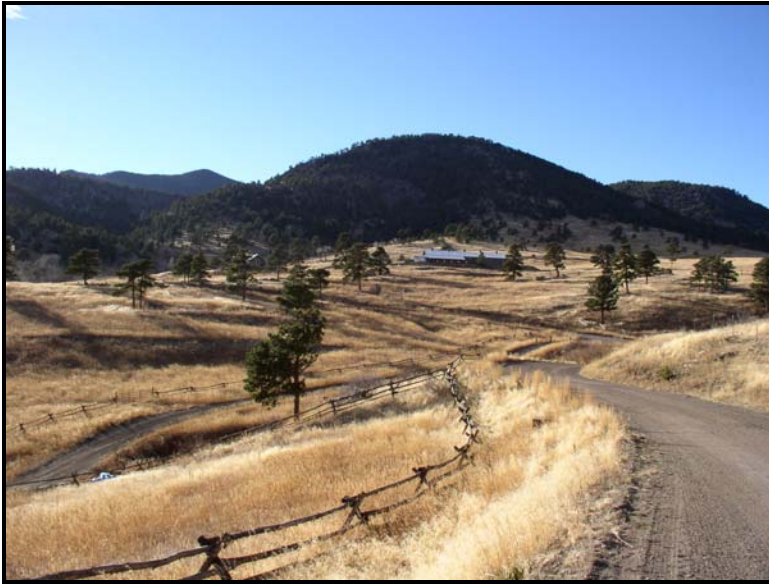
Figure 19

Hazard Rating:	Low
Does the neighborhood have dual access roads?	Yes
Are there road grades $\geq 10\%$?	No
Are all access roads of adequate width?	Yes
Average lot size:	>5 Acres
Fuel models found in the neighborhood:	1, 2, 10
Water supply:	Many draft ponds
Hazards:	Ravines

This neighborhood has light to moderate loads of mostly FM 1 and FM 2. Slopes near most of the homes in this community are generally less than 15%. The upper (western) area is steeper (up to 30% slope) and has a higher fuel load (FM 10), but there are few homes here and the access is good. This community is comprised of primarily well-built homes with ignition resistant roofs on large lots. There are a few historic, and very flammable, ranch buildings, but most are a significant distance from residences. There is a good water supply and access to structures is good. Most homes have good defensible space.

Most homes need reflective addressing. Some homes in the western end may need extended defensible space.
